Mechanical Demolition of Buildings with Concrete Asbestos Board Siding: Methodology, Precautions, and results at the Hanford Central Plateau

Date Published
February 2012

Mechanical Demolition of Buildings with Concrete Asbestos Board Siding: Methodology, Precautions, and Results at the Hanford Central Plateau - 12417

Kurt Kehler, Vice President of Decommissioning and Demolition
CH2M HILL Plateau Remediation Company, Richland, Washington

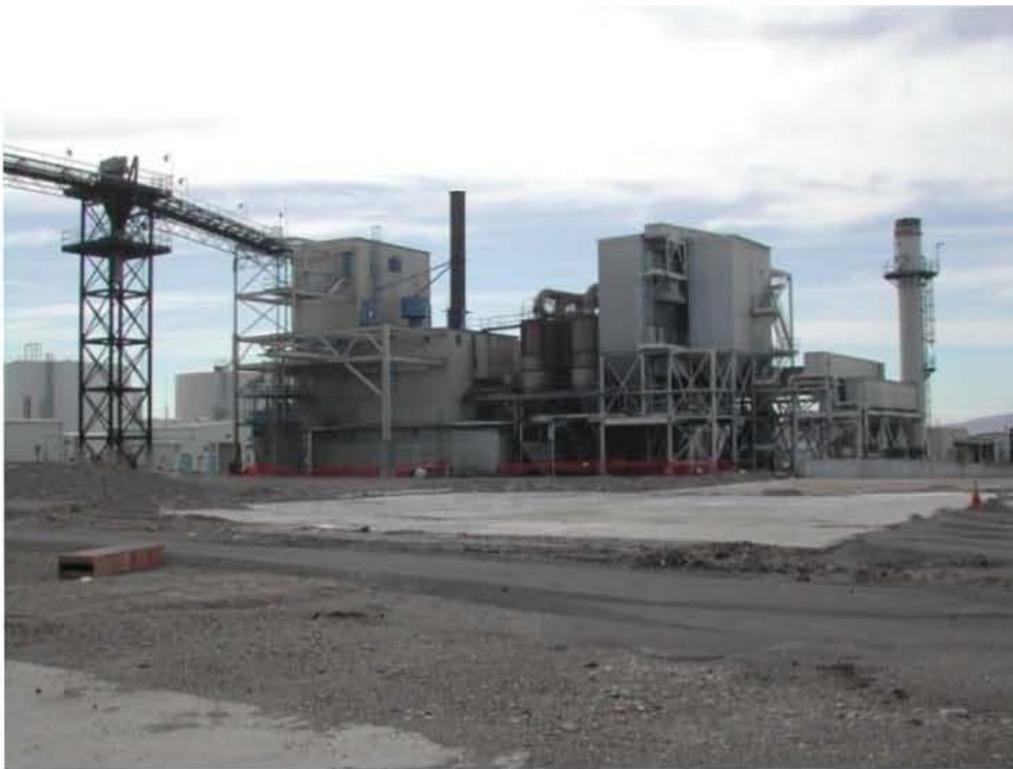
Figure 1 – 384 Powerhouse demolished in 2008.

In 2008, CH2M HILL (as the demolition team member in Washington Closure Hanford LLC) performed the mechanical demolition of the 384 Power House. The 384 Powerhouse had CAB on the exterior walls and roof. Structural evaluations of the roof indicated it was not in condition to support manual removal of the panels. CH2M HILL worked with the client and the regulators to get approval to mechanically demolish the structure. Successful demolition occurred with no incident and no exposures of personnel above the Permissible Exposure Limit (PEL).

While the regulation is clear that RACM must be removed from the building prior to demolition, it does not take into account other factors, such as the inherent risk to the workers of the removal itself. Hanford has experienced injuries and even fatalities from working at heights and specifically on weak roofs. Manual removal of CAB from the 384 Powerhouse posed a much higher risk due to falls and other injuries than the potential risk of making the ACM friable (therefore regulated). There was one portion of the roof of the 384 Powerhouse that was damaged and other portions that could not even be inspected.

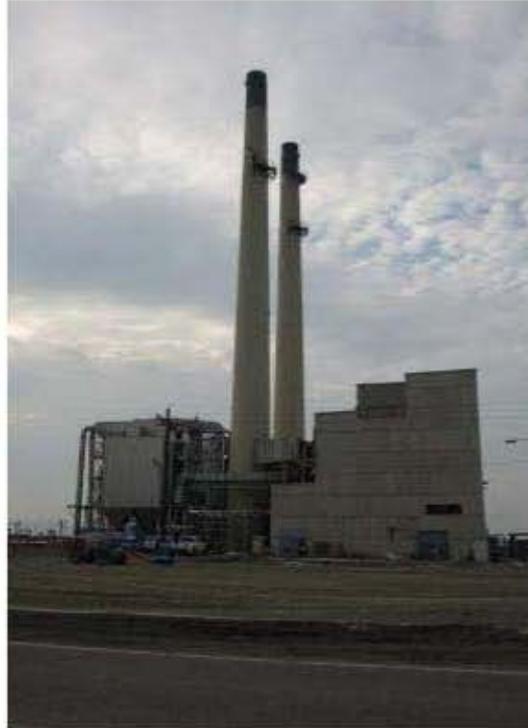
Figure 2 – 284-W Powerhouse demolished in September 2011

The 284-W Powerhouse (Figure 2), where demolition was completed in September 2011, is a positive example of the continuing results for the approach at Hanford. The structure was demolished and loaded out in 20 days with CAB in place. No asbestos exposures over the PEL were detected by 130 boundary air samples taken. Personal (lapel) monitors also showed no detectable asbestos releases.
