Publication Images: The Good, the Bad and the Impossible

Norris D. Flagler¹, Eli Ney¹, Beth W. Mahler² and Robert R. Maronpot¹

Photomicrographic images that are submitted to *Toxicologic Pathology* for the purpose of documenting scientific findings range in quality from the good and the bad, to the impossible. Some of the most common problems with manuscripts submitted to *Toxicologic Pathology* are uneven illumination, out of focus photomicrographs, overexposed immunohistochemistry and inappropriate labeling. Examples of various common errors in submissions will be presented along with possible solutions achieved by the utilization of an image-processing program, such as Photoshop®. Some worst-case scenarios of "impossible" images will also be examined.

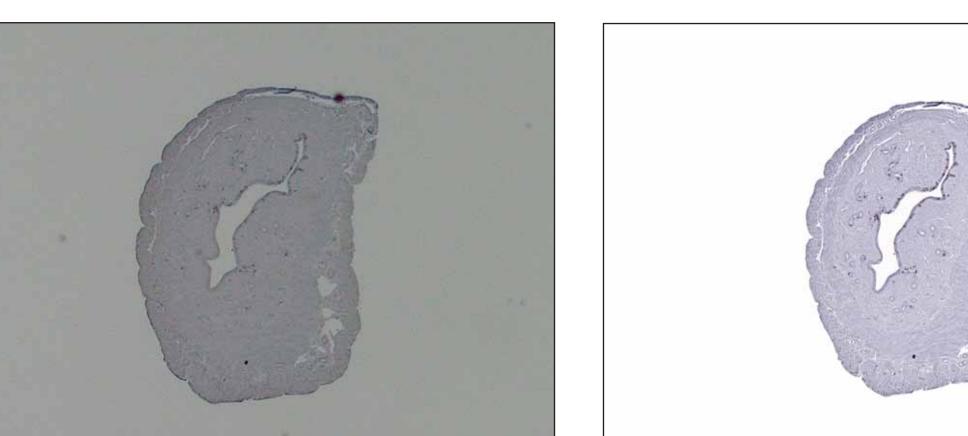
Figure 2A represents an image where the specimen was not properly illuminated.

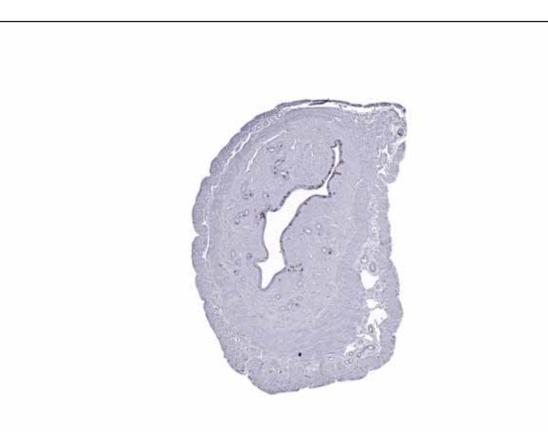
Figure 2B represents an image where the light source has been optimally adjusted.

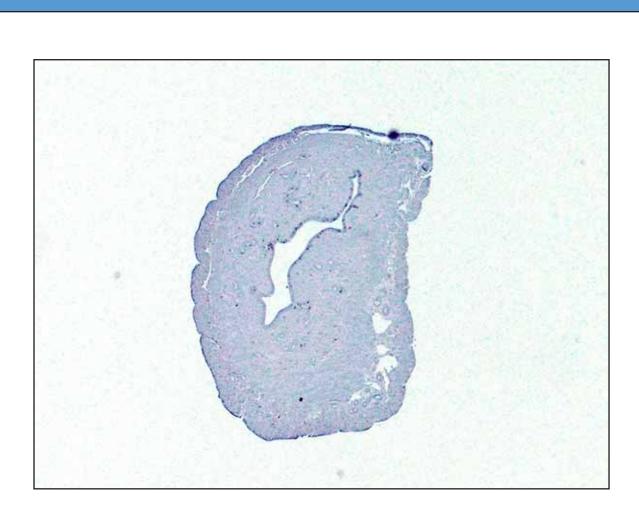
Figure 2C represents image 2A that has been adjusted in Photoshop® by increasing the illumination. This image is NOT acceptable for submission to *Toxicologic Pathology*.

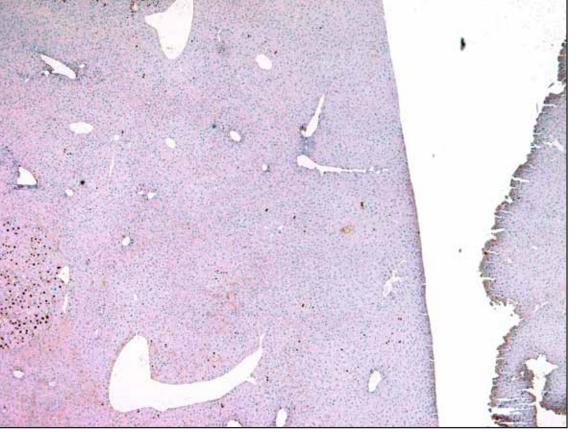
Figure 3B represents an image where the field diaphragm has been properly adjusted to eliminate

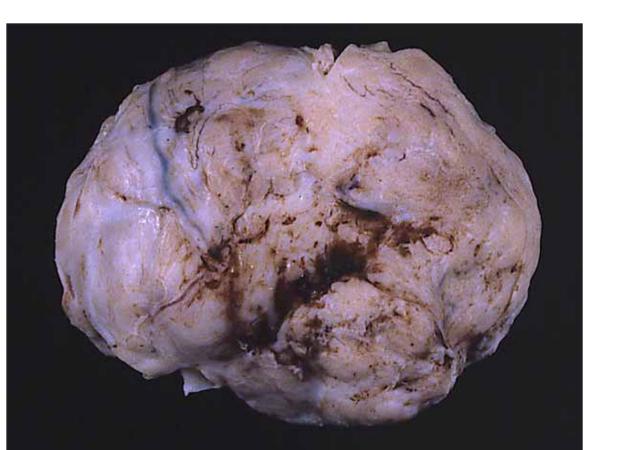
kodachrome slide with poor illumination and a color caste.
